NACA TN 3190

FATIGUE INVESTIGATION OF FULL-SCALE
TRANSPORT-AIRPLANE WINGS

SUMMARY OF CONSTANT-AMPLITUDE TESTS THROUGH 1953

By M. J. McGuigan, Jr., D. F. Bryan, and R. E. Whaley

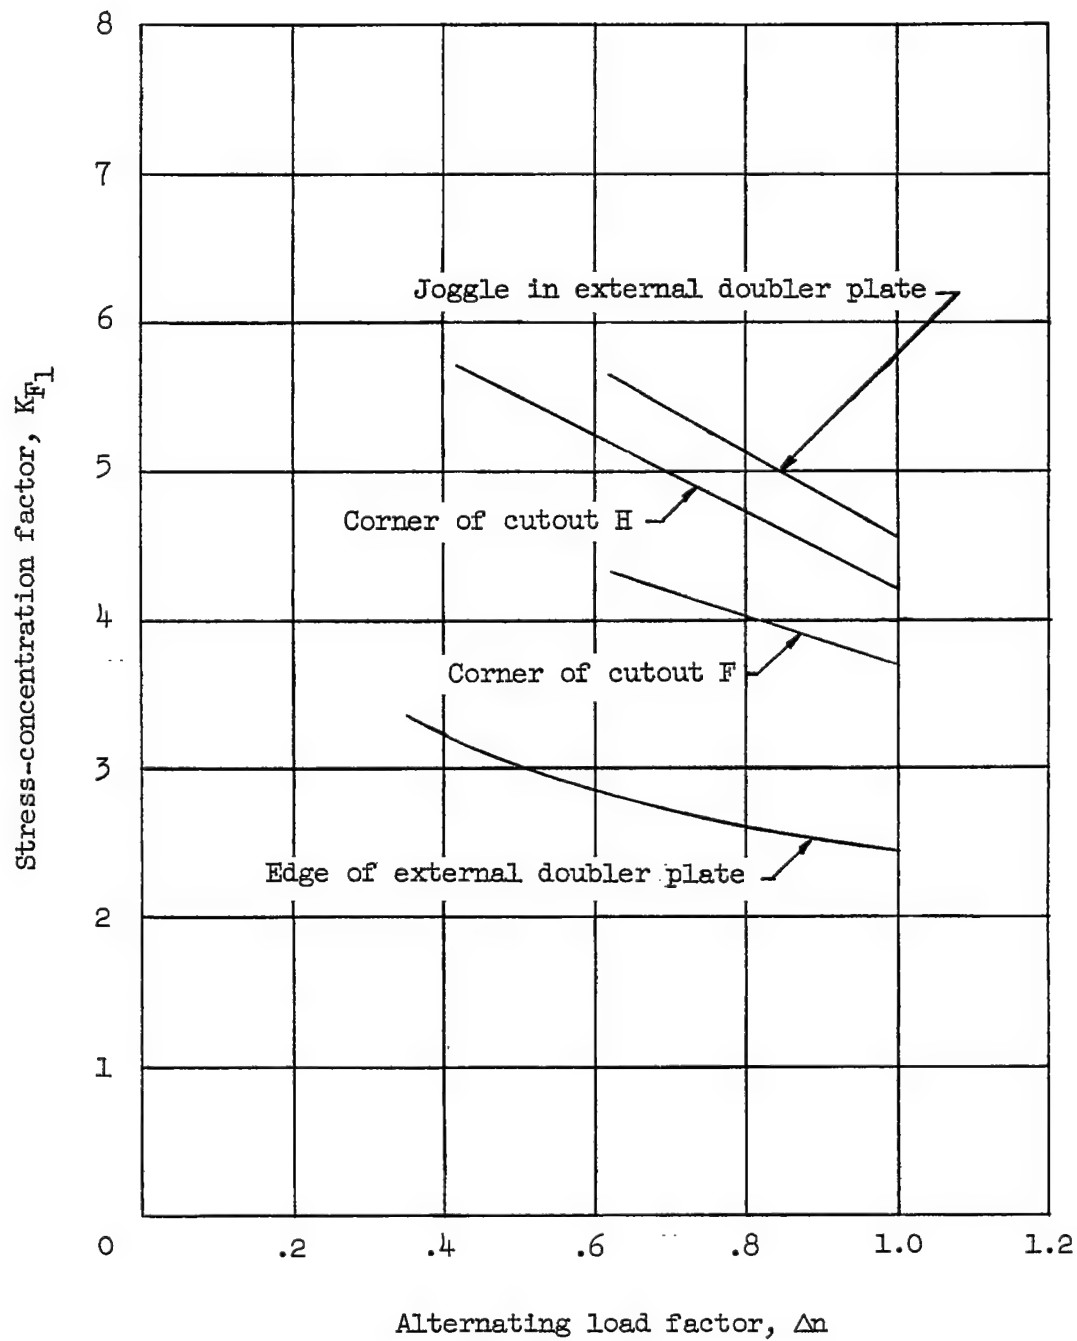
The range of concentration factor K_{F1} occurring at each load level for the five types of failures is shown in table 2. It can be noted from this table that the concentration factor tends to decrease with increasing load level. This trend is shown graphically in figure 10 for several locations where failures occurred at more than one load level. The trend is assumed to be caused by the increasing effects of plasticity associated with higher stresses as the load level is increased. Both K_{F2} and K_{F3} show the same decreasing trend with increasing load level that K_{F1} does, but in the case of K_{F3} the trend is not very apparent because of the lower magnitudes involved.

Figure 10.- Effect of load level on the stress-concentration factor.
